# Interim Assessment of the VAL Automated Guideway Transit System

November 1981  
Interim Report

| 7. Author(s)<br>G. Anagnostopoulos | | 8. Performing Organization Report No.<br>DOT-TSC-UMTA-81-34 | |

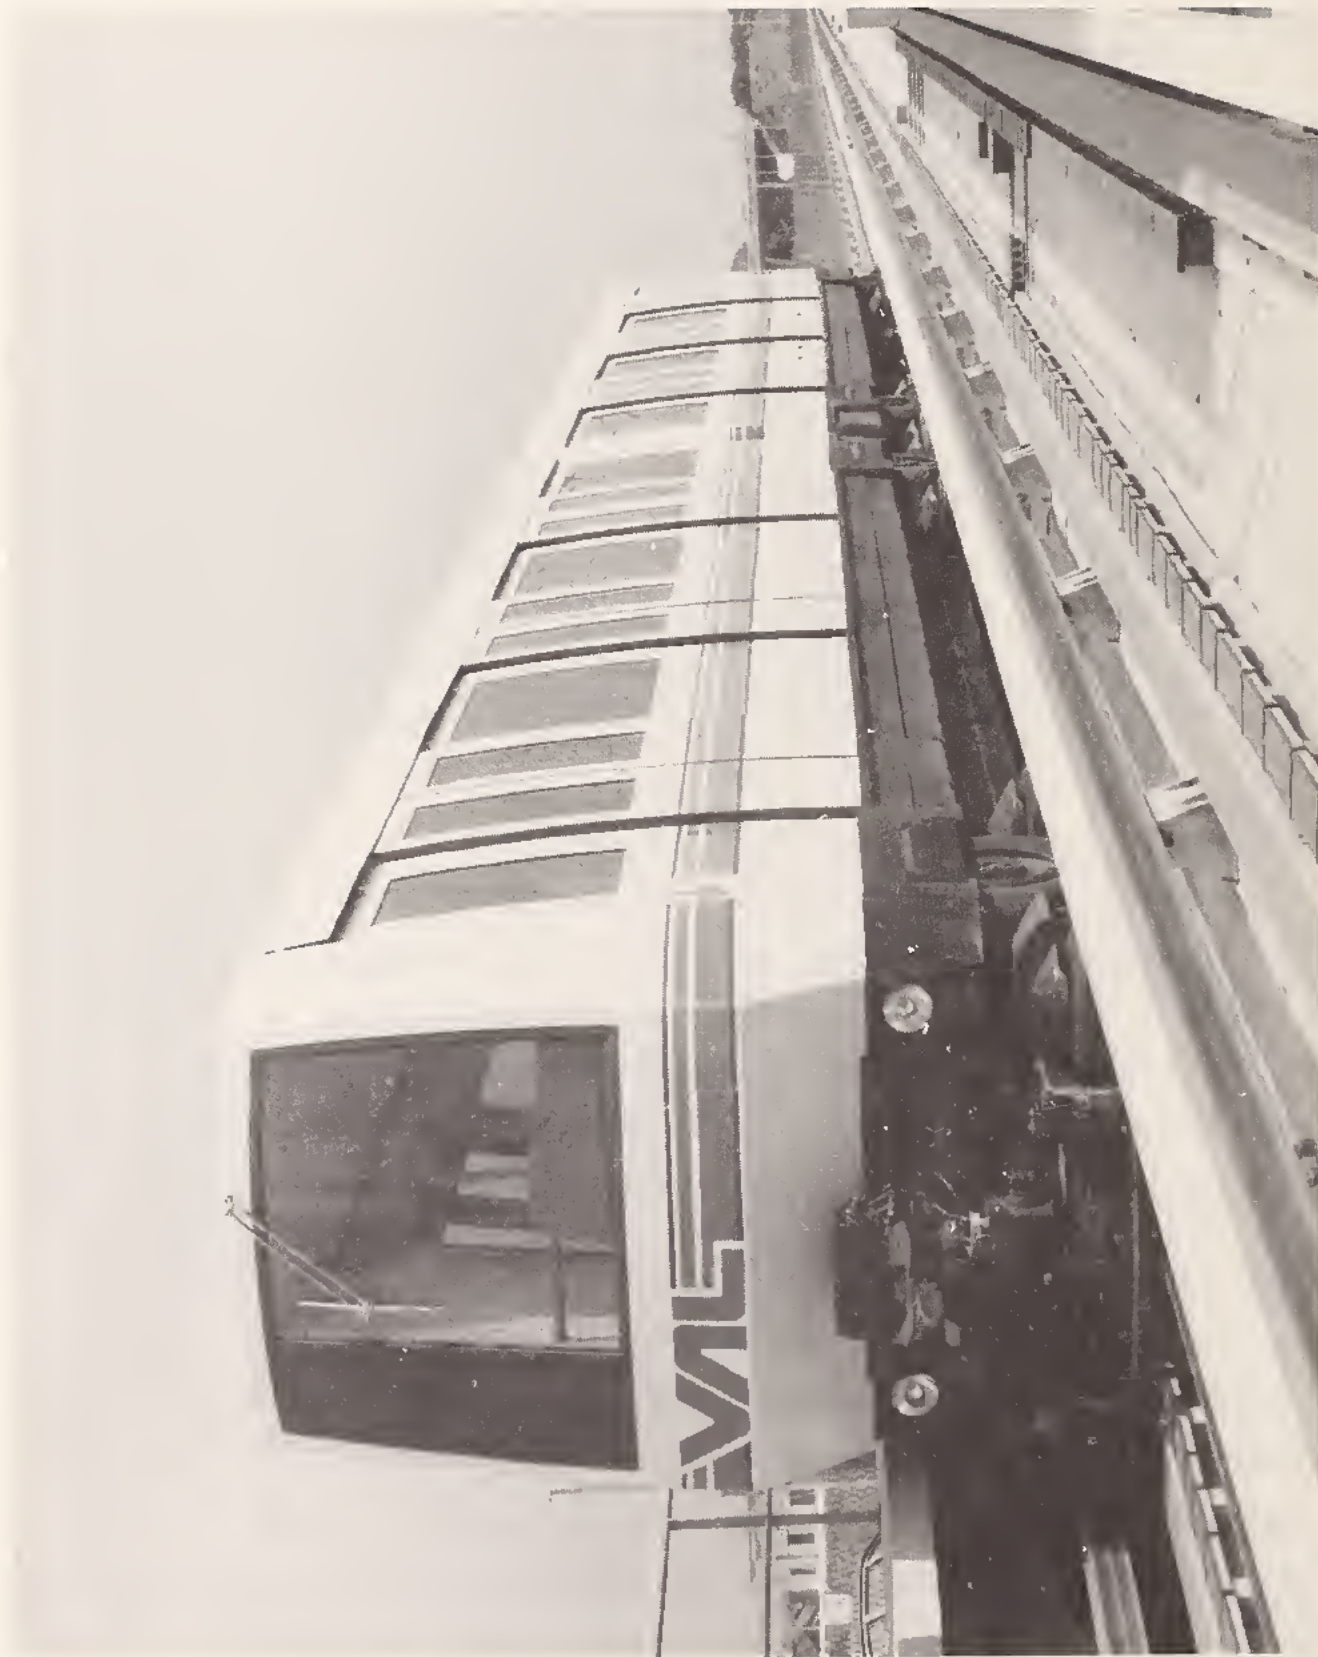
FIGURE ES-1. VAL SYSTEM

From 1971 to 1975 a prototype development program was conducted which included the design, development and testing of two prototype vehicles on a 1.7-km test track in Lille. This development phase cost 45 million French francs (approximately \$9 million).

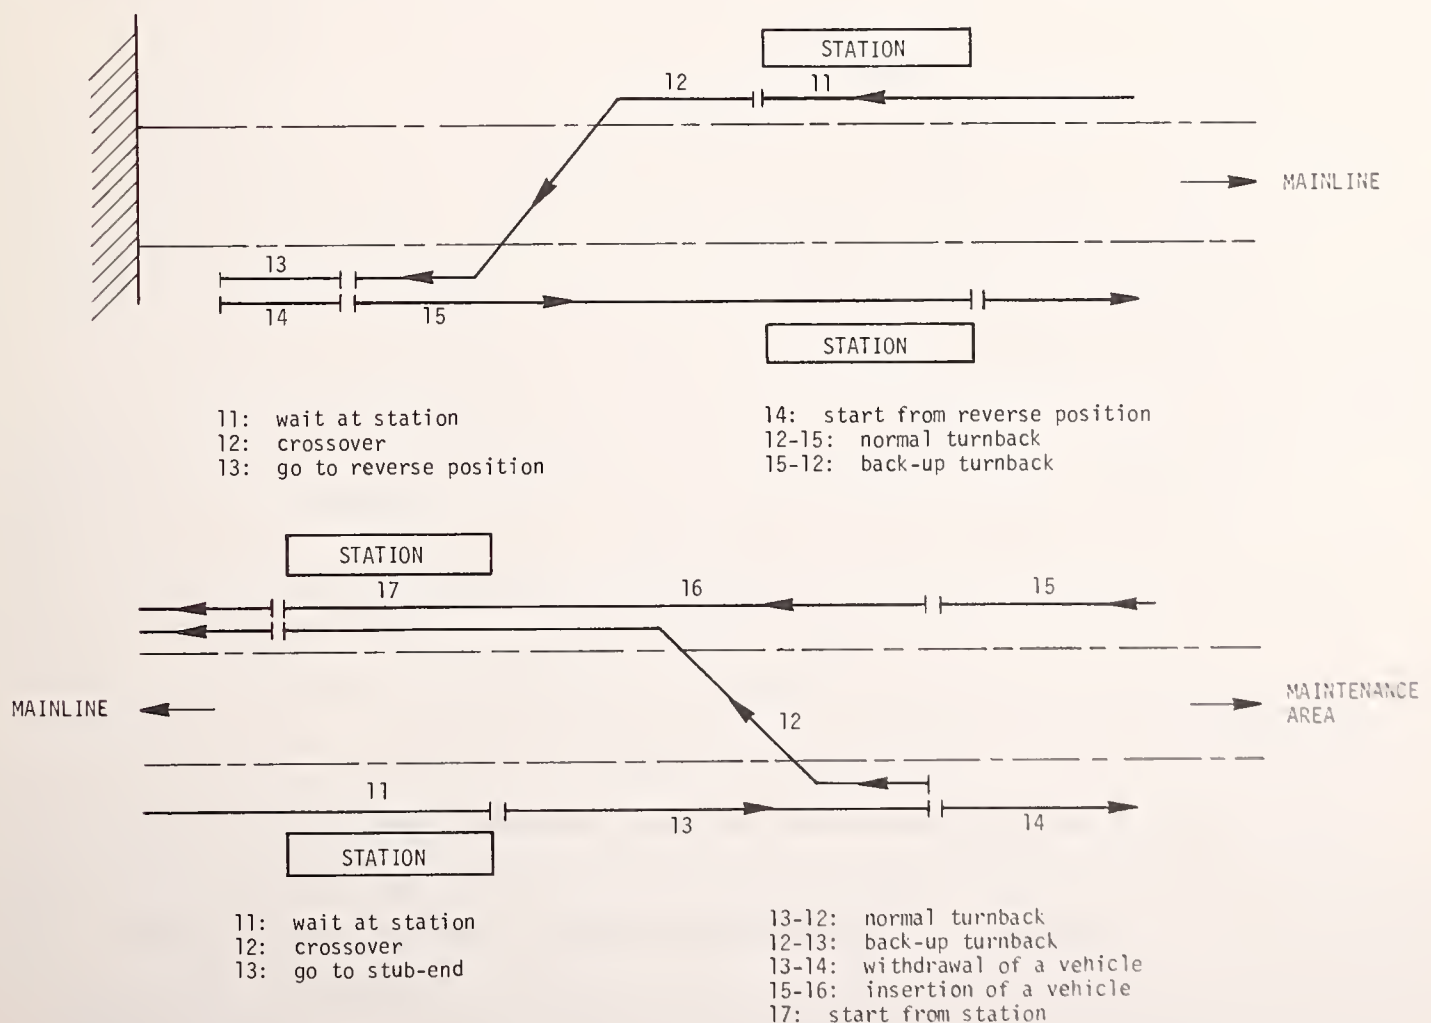
FIGURE 3-38. AUTOMATIC ROUTE OPTIONS AT TERMINALS

The functional capability for automatic route operations at terminals is schematically indicated in Figure 3-38. This is given for two cases, a main-line-to-maintenance and a terminus. The terminals are provided with a single crossover behind each station. Turnback operation is completely automatic. The maintenance area is provided with crossovers and switches for automatic operation between the workshop, storage area, wash stand, test area, and the mainline. Insertion and withdrawal of vehicles from the mainline to maintenance is also completely automatic. This operation is initiated and supervised by Central Control.
