## Railway track and structures

vol. 101, n° 11, novembre 2005, pp. 19-21 et 34, phot. - (REVUE) - S/C : 0310

# FAST heavy-axle-load update

**TTCI provides an update of what's going on at the facility that has provided the industry with invaluable information on rail performance, welding, bridges and other track components.**

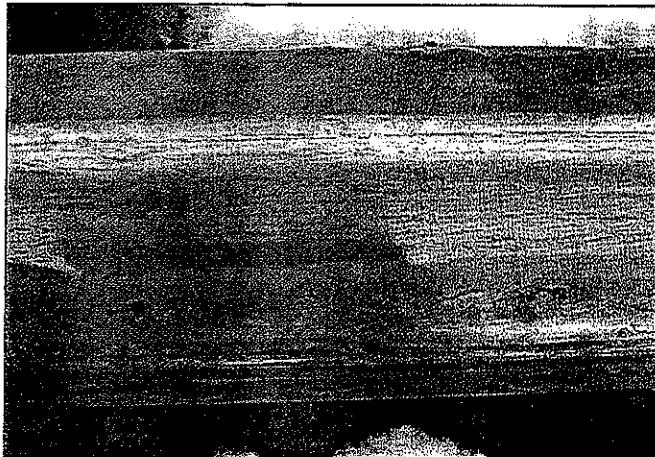
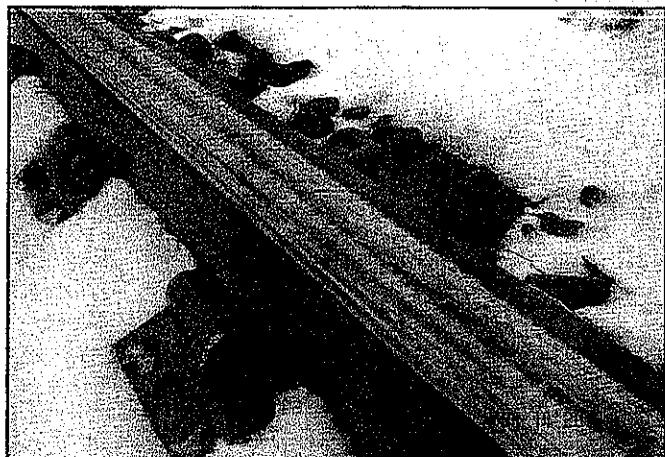
Figure 1, left and right, shows rolling contact fatigue in test rails.

The rails required no grinding and surface conditions remained generally good, with the exception of some rolling contact fatigue that began to appear about 300 mgt into the test (Figure 1). There were more rail breaks that initiated in the base during this test than in previous ones. Preliminary analysis showed that the higher hardness rails have reduced fracture toughness compared to rails previously tested. The effect of fracture toughness on the increase in base breaks requires further investigation.

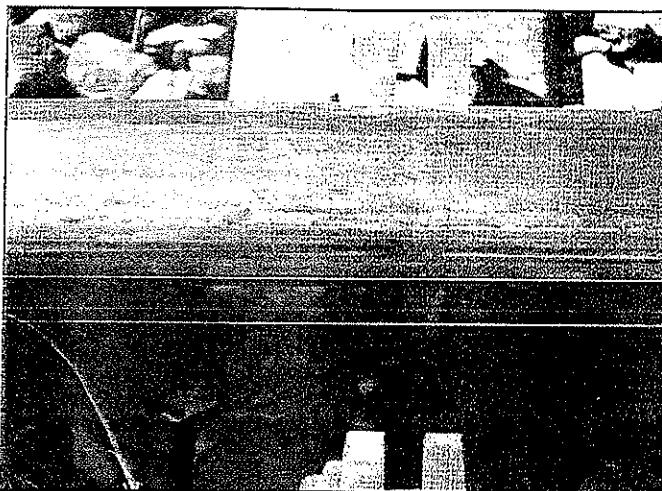
Figure 2, left, is a slot weld after 194 mgt. Figure 3 is a miter rail joint on the FAST steel bridge.

Fourteen slot welds have been installed at FAST, 12 in 2004, and two in 2005. Nine of the 12 welds installed in 2004 remain in track after 194 mgt. Two were removed due to the propagation of fatigue defects, as indicated by ultrasonic inspection. None of the welds failed. Both welds installed in 2005 remain in track after 54

mgt. The condition of the welds in track is good, with little flow or deformation (Figure 2). Testing at FAST has helped Holland identify weld process issues. They have been addressing the issues to ensure weld cleanliness and improve the in-track welding process. Slot welds are now being tested in revenue service.
